## **ADDENDUM NO. 01**

Project: Camp Murray Beach Sewer Maintenance & Historical Dist. Sewer Repairs Washington Military Department, State Project #2016-644/645

2. C1.1A: HISTORICAL DISTRICT SEWER REPAIR - ALTERNATE 1

3. C1.1B: HISTORICAL DISTRICT SEWER REPAIR – ALTERNATE 2

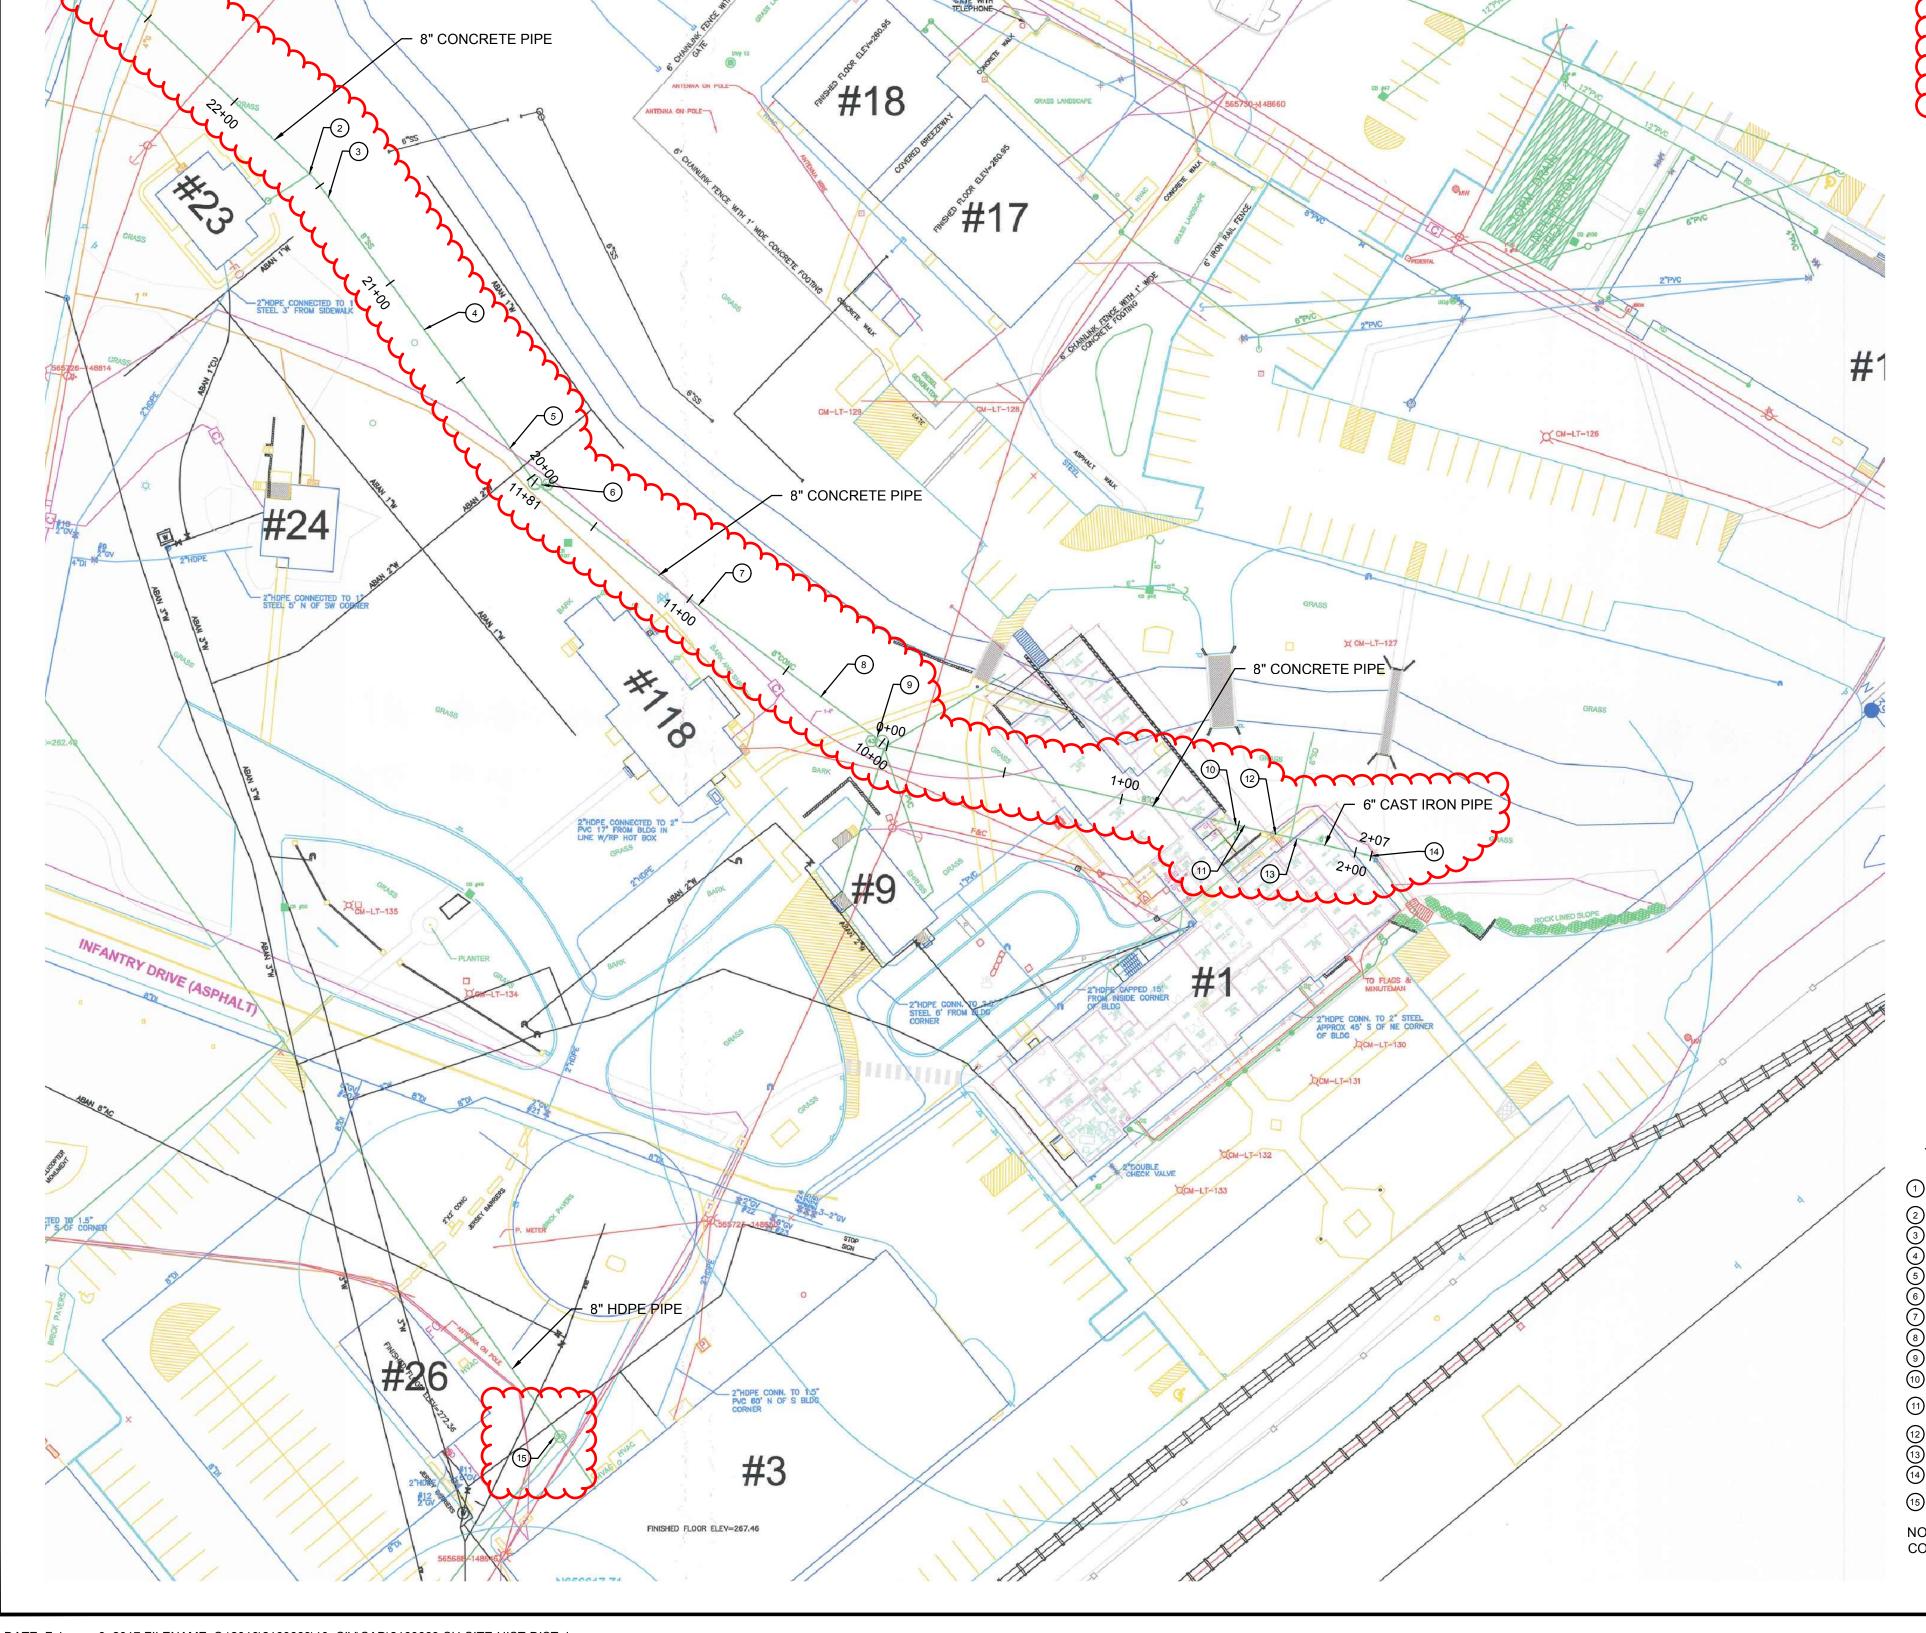
C1.1A

HISTORICAL DISTRICT SEWER REPAIR -ALTERNATE 1

- 1. PROVIDE CURED-IN-PLACE PIPE (CIPP) SYSTEM ALONG APPROXIMATELY 210LF OF EXISTING DETERIORATING 6-INCH AND 8-INCH PIPE AS IDENTIFIED ON THIS SHEET.
- REHABILITATE 1 BRICK MANHOLE WITH CEMENTITIOUS MORTAR LINING (CML).
- 3. REHABILITATE 1 CONCRETE MANHOLE TO MAKE WATER-TIGHT.
- PROVIDE NEW SEWER MAIN PARALLEL TO EXISTING SEWER MAIN:
- PROVIDE APPROXIMATELY 450 LF OF NEW 8" PVC SEWER MAIN AND 4 SEWER MANHOLES. EXTEND EXISTING SEWER SERVICES TO NEW MAIN WITH SERVICE TEES.
- .3. ABANDON EXISTING SEWER MAIN..4. CONTRACTOR SHALL ASSUME UP TO 8' DEPTH TO PIPE INVERT AND INCLUDE DEWATERING IN
- 5. RESTORE LAWN TO EXISTING OR BETTER CONDITION. ALL AREAS DISTURBED BY CONSTRUCTION EQUIPMENT (INCLUDING FOR ACCESS AND TRENCHING) SHALL BE RESTORED WITH 4" TOPSOIL, RAKED,
- REMOVE AND REPLACE SIDEWALK TO NEXT NEAREST JOINT AT SEWER TRENCH. PROVIDE 4" MINIMUM DEPTH CONCRETE ON LINYIELDING SUBGRADE

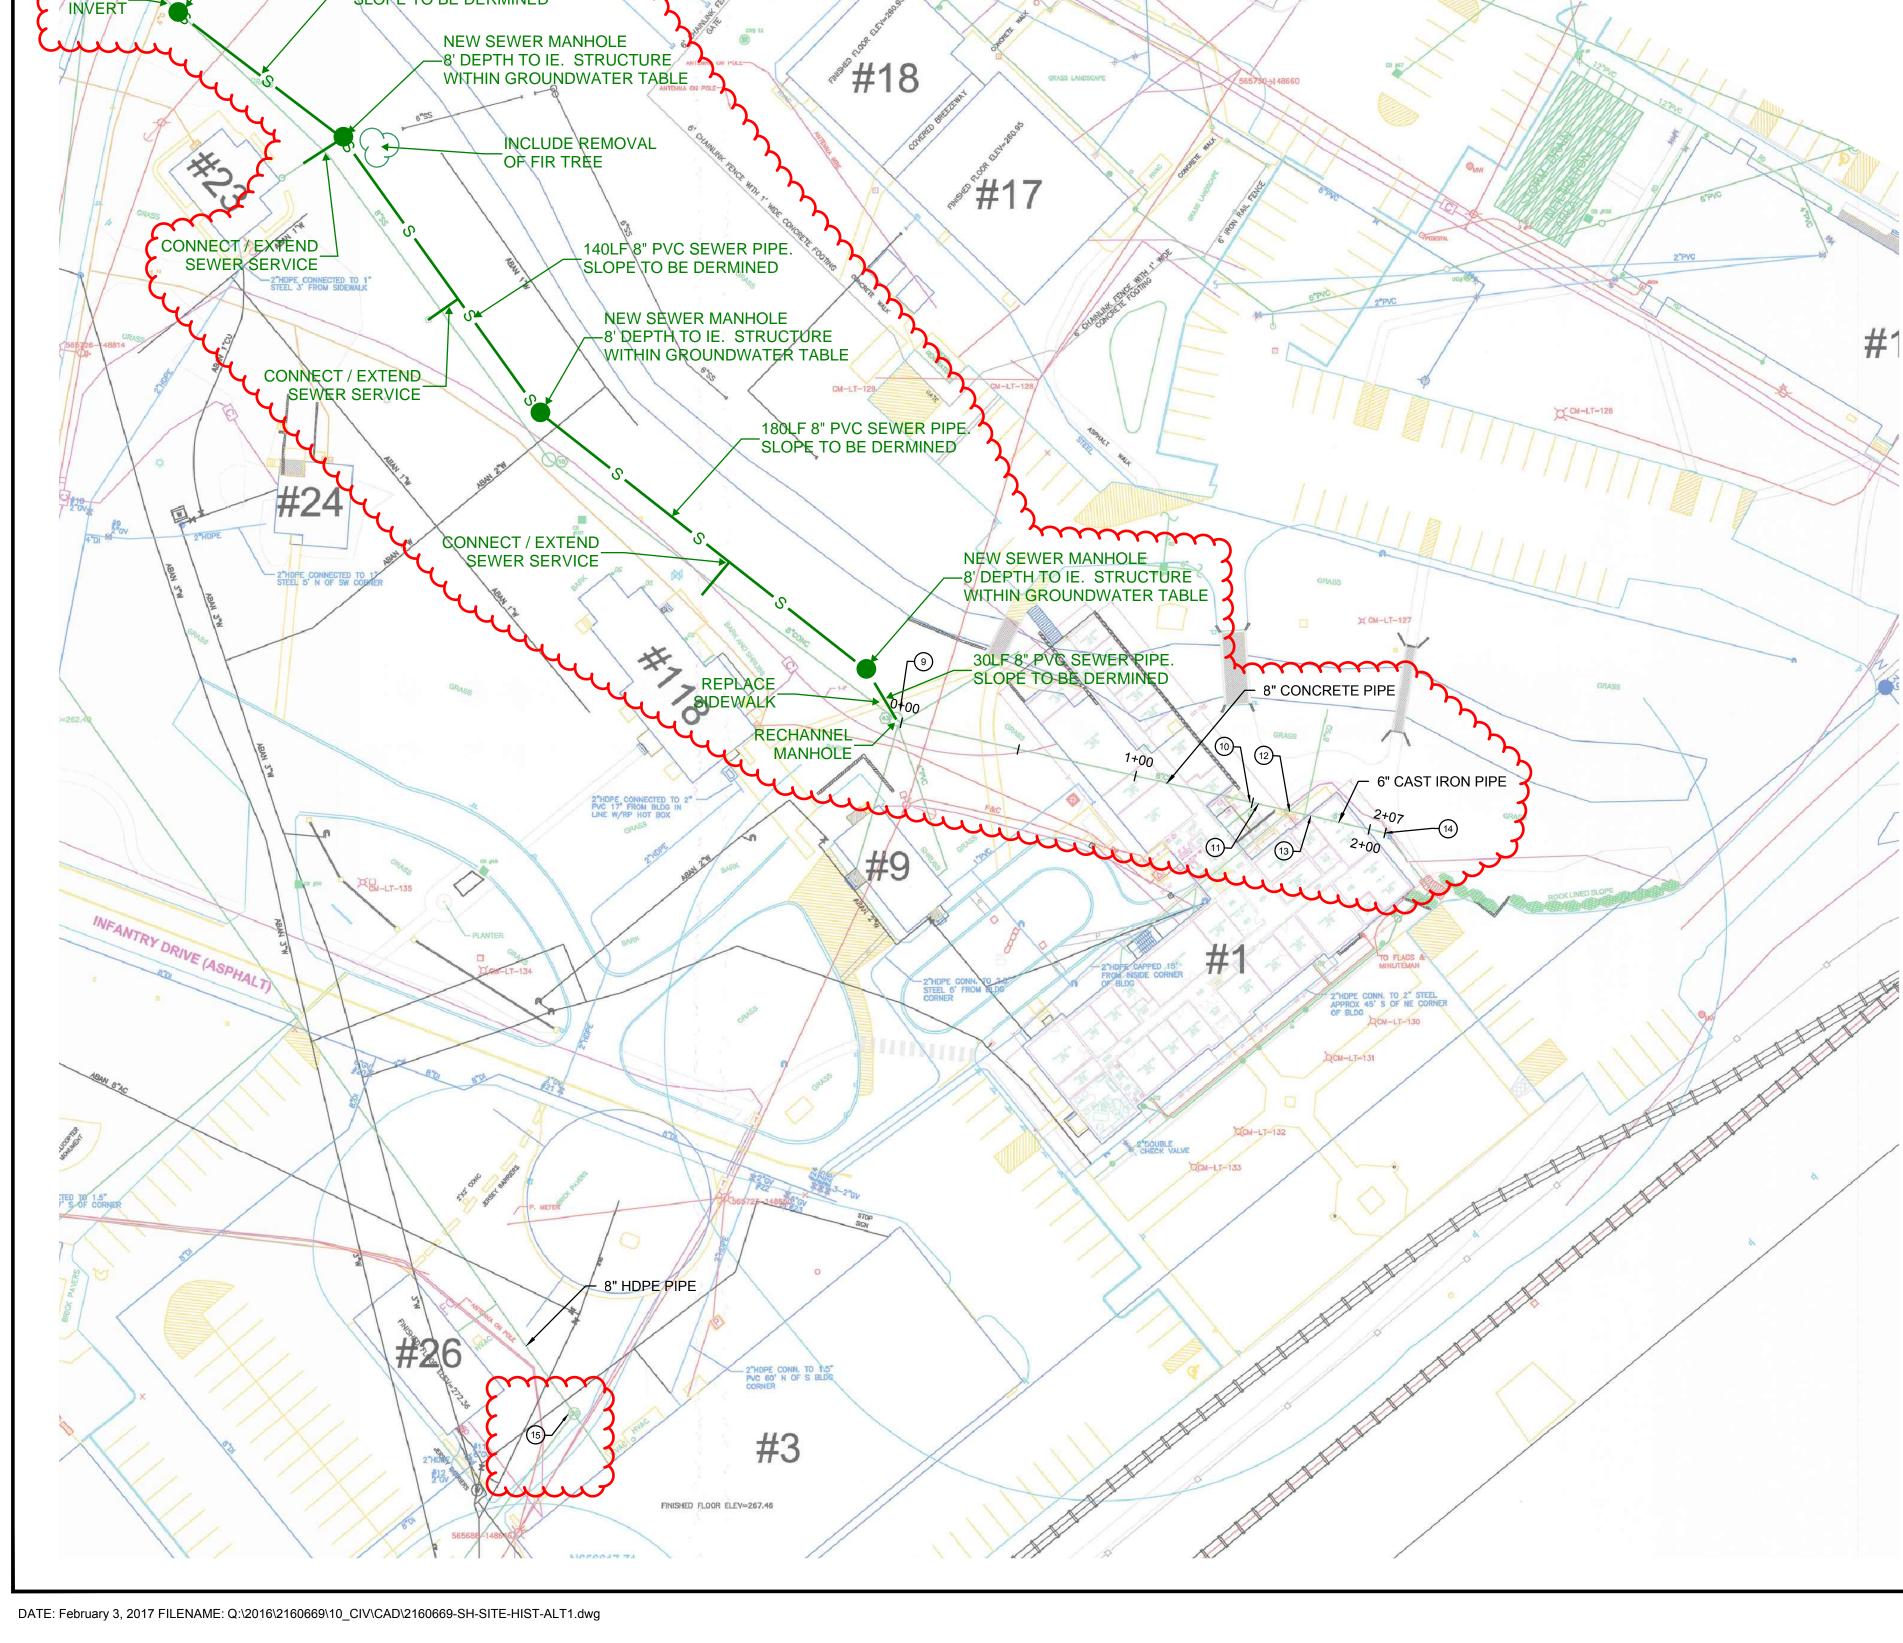
C1.1E

# SEWER REPAIR -ALTERNATE 2
